SF Rush the Rock

Field Service Bulletin

U17 Heatsink

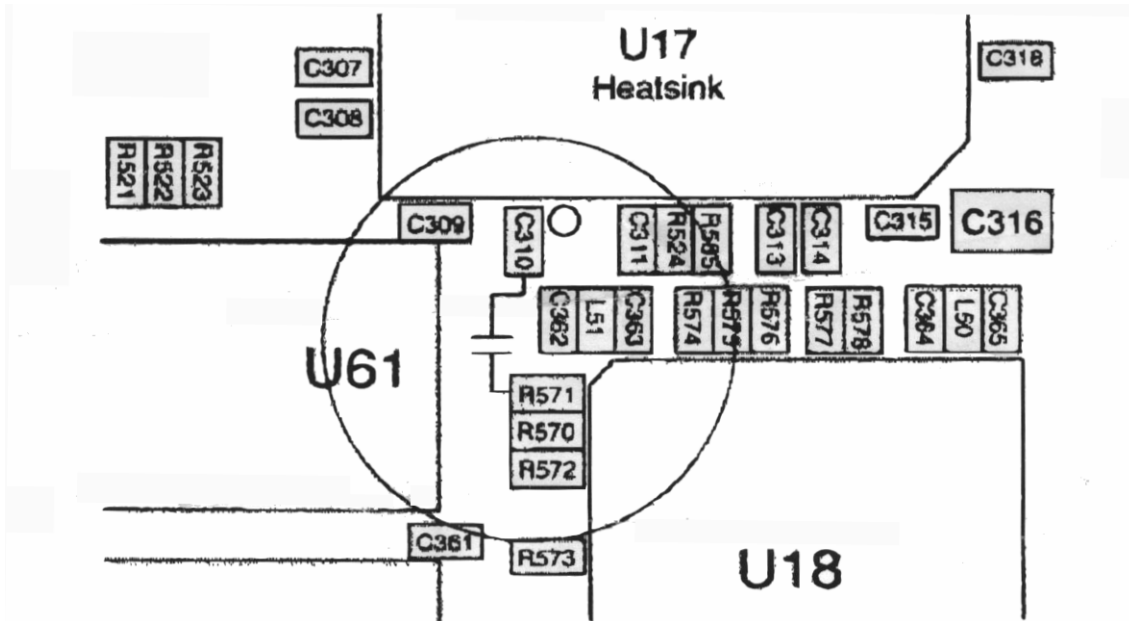
It has come to our attention that some **SF Rush the Rock** CPU boards (PN. #'s A-21937) may exhibit a reset problem. Symptoms are: the game freezes then re-boots during game play. To fix this timing error, solder a 10pF 10% axial capacitor (part # 5048-12503-00) from the load side of R571 to the ground side of C310. See below for an exploded view of the exact location on the board of the added capacitor.
