Service Bulletin N° 93

SUBJ: F.Y.I We have identified a problem in a small quantity of I/O Power Driver Boards (less than 50) that may have been installed into Space Jam Games. (Sorry, but we are unable to supply a serial number breakdown for verification.)

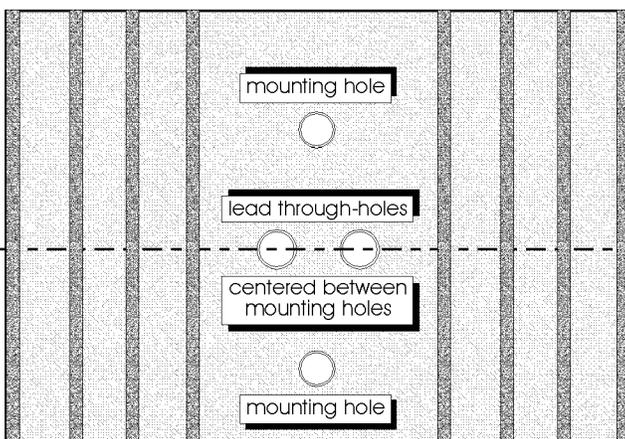
Fig. 1 Incorrect

Explanation: The heat sink for the LM338K +5 Volt Regulator (TO-3 Transistor Package) was incorrectly manufactured (the through-holes in the *Heat Sink* for the two leads of the LM338K were not located correctly and may short the leads against the *Heat Sink* or the *Heat Sink to the Solder Pads* (See Fig. 1).

When this occurs, the unregulated input DC voltage (approx. 8 ~ 9v DC) can be directly shorted to the *Heat Sink* and thus to the case of the regulator. Since the regulator case is also the regulated voltage output connection, this means that 8 or 9v DC can appear on the +5 Volt Power Bus of the game. This will cause an assortment of strange symptoms ranging from random game malfunction (chattering flippers, bad Dot Display, bad sound) to failure of other game PCBs due to overvoltage conditions. **The best way to verify this condition in your game is to simply meter the +5 Volt supply. If you see any reading higher than 5.5v DC, the heat sink is the prime suspect.**

The **next step in verification** is a little more complicated: the regulator must be de-soldered from the I/O Board and the through-hole location for the transistor leads on the *Heat Sink* should be inspected. If the two holes are **CENTERED** between the two mounting holes (on the ends) instead of *offset* (closer to one of the mounting holes, matching the leads on the TO-3 Case), the *Heat Sink* is **BAD** (See Fig. 1).
