January 31, 1983

## TECHNICAL UPDATE

### POLE POSITION™

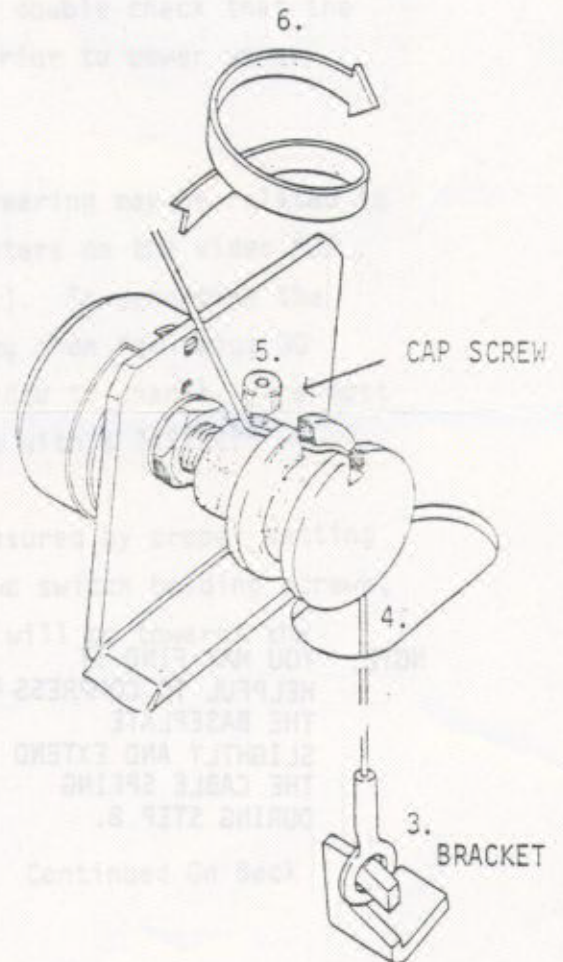
"REWINDING THE PULLEY CABLE"

1. PLACE FOOT-PEDAL CONTROL ASSEMBLY UPSIDE DOWN ON WORK SURFACE WITH PEDAL IN FULLY-OPEN POSITION AND HINGED END AWAY FROM YOU.
2. ROTATE PULLEY UNTIL CAP SCREW POINTS STRAIGHT UP.
3. HOOK THE LARGER-DIAMETER EYELET OF THE CABLE TO THE FOOT-PEDAL BRACKET.
4. THREAD THE CABLE UP THROUGH THE BASE-PLATE OPENING.
5. WRAP THE CABLE 1/4 - TURN AROUND THE PULLEY AND BRING OUT THROUGH THE NOTCH TOWARD THE CAP SCREW.
6. WRAP THE CABLE TWICE AROUND THE CAP SCREW IN A CLOCKWISE DIRECTION.

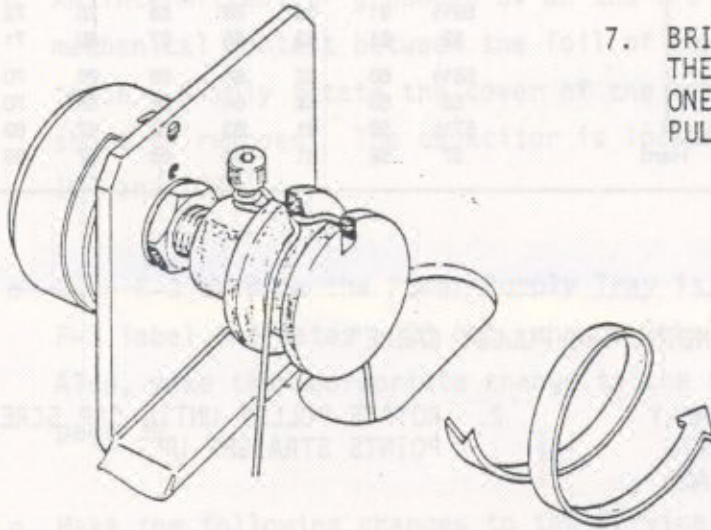
- BRING THE CABLE BACK THROUGH THE NOTCH AND WRAP ONE AND ONE-HALF TURNS AROUND THE PULLEY.

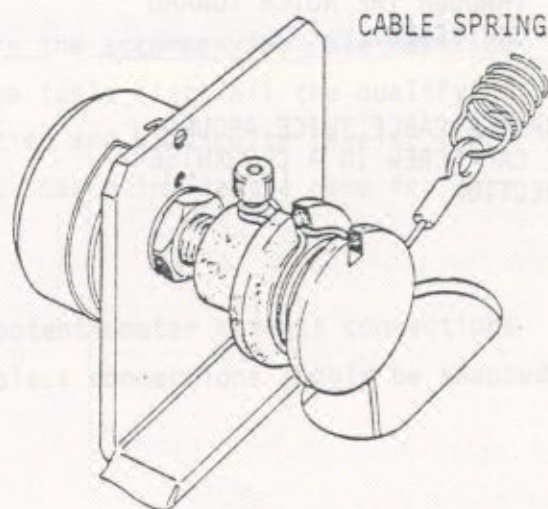
- ATTACH THE SMALLER EYELET ON THE CABLE TO THE CABLE SPRING.

NOTE: YOU MAY FIND IT HELPFUL TO COMPRESS THE BASEPLATE SLIGHTLY AND EXTEND THE CABLE SPRING DURING STEP 8.
