TECH TIP

from the ATARI FIELD SERVICE DEPARTMENT

ROADBLASTER

Road Blaster Vertical Roll problem

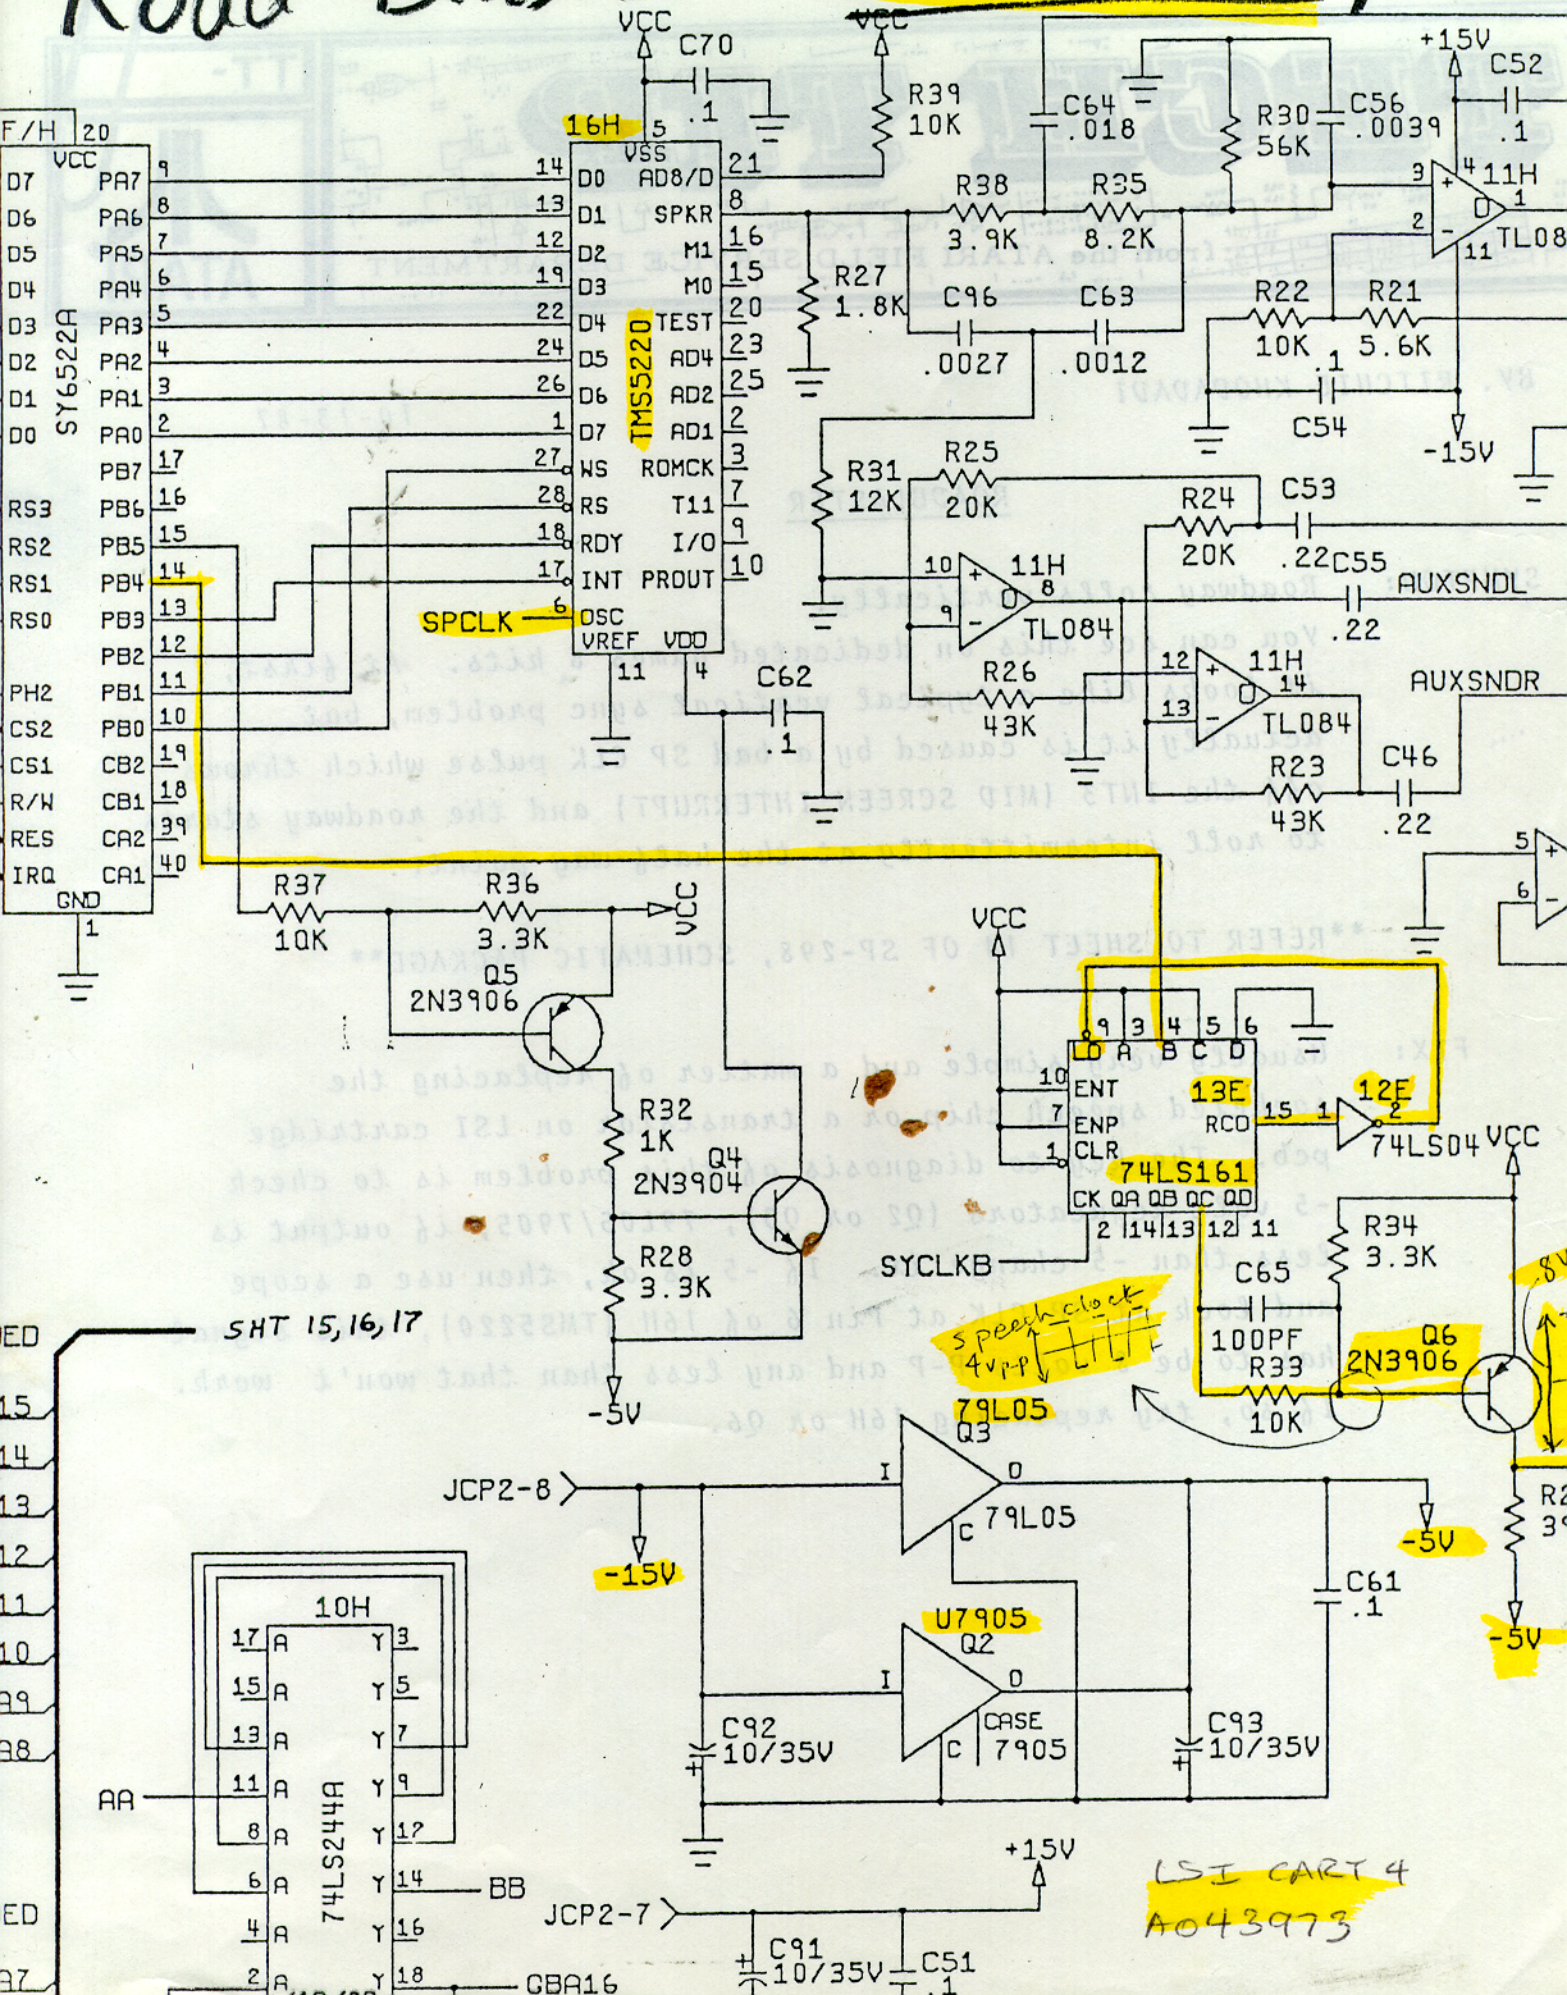
****REFER TO SHEET 14 OF SP-298, SCHEMATIC PACKAGE****

SYMPTON: Roadway rolls vertically.
You can see this on dedicated games & kits. At first, it looks like a typical vertical sync problem, but actually it is caused by a bad SP CLK pulse which throws off the INT3 (MID SCREEN INTERRUPT) and the roadway starts to roll intermittently at the half-way point.

FIX: Usually very simple and a matter of replacing the socketed speech chip or a transistor on LSI cartridge pcb. The key to diagnosis of this problem is to check -5 volt regulators (Q2 or Q3), 79L05/7905, if output is less than -5 change it. If -5 is ok, then use a scope and look at SP CLK at Pin 6 of 16H (TMS5220), this signal has to be 8 volts P-P and any less than that won't work. If so, try replacing 16H or Q6.
